MuLan Kicker New Installation

F. Mulhauser, J. Jungmann

September 1, 2005

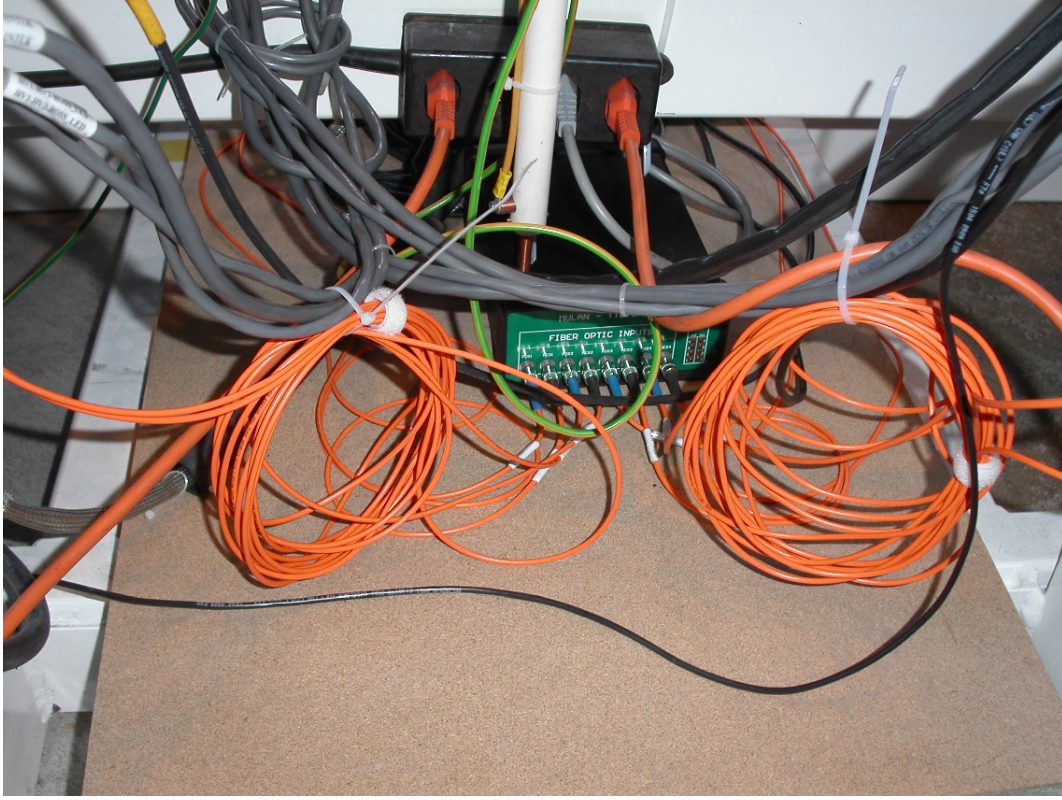
- The installation of the fiber-optic cable was performed and can be seen at www.npl.uiuc.edu/mulhauser/mulan/kicker/aug-23-2005/index.html. The box installation is shown in Fig. 2. In addition to the description, a reset button is located at the back of the box. It has to be pressed by the operator, to allow the kicker to function again after a trip.

Figure 2: This box replace the previous TTL distribution box. It is located at the center of the kicker, on the lower frame. The visible front view shows the possible over-current trip LEDs. The non-visible back view has the TTL input signal, the four TTL output signals, towards each cabinet, and the TRIP monitor TTL signal as well as optical out for relay purpose.

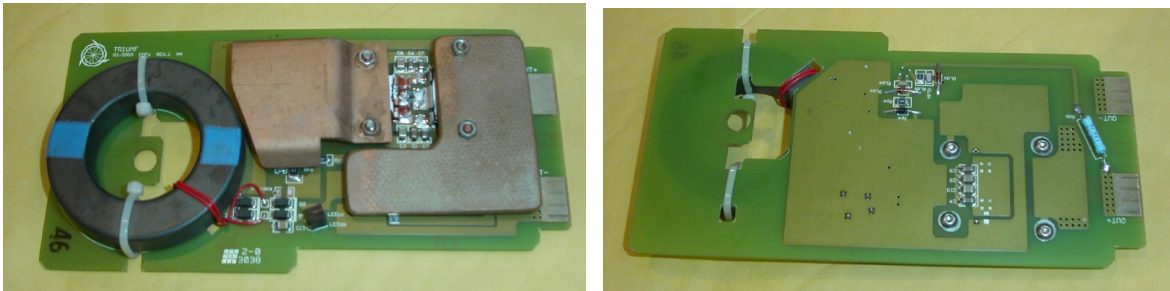
Because not many of us are specialists, you will see pictures of one MOSFET card in Fig. 3. On the front side, you see well the ferrite, through which the 315 V cable goes as well as the copper shielding of the diode itself. Of particular interest is also a small resistor located in position C13. On the back side, one has a visible view of a long blue resistor. Some cards came back from TRIUMF with this resistor de-soldered. Also nicely visible are the drain (OUT +) and source (OUT -) pads.

Figure 3: *Front and back sides of one MOSFET card. On the front side, one sees the ferrite, the copper shielding of the MOSFET and other electronic parts. Of particular interest is the small resistor located on position C13 (lower middle part). On the back side, one sees clearly the long blue resistor, as well as the drain (OUT +) and source (OUT -) pads.*
